TECHNICAL REPORT ARCCB-TR-98018

COMPREHENSIVE EROSION MODEL FOR THE 120-MM M256/M829A2 GUN SYSTEM

OCTOBER 1998

US ARMY ARMAMENT RESEARCH, DEVELOPMENT AND ENGINEERING CENTER

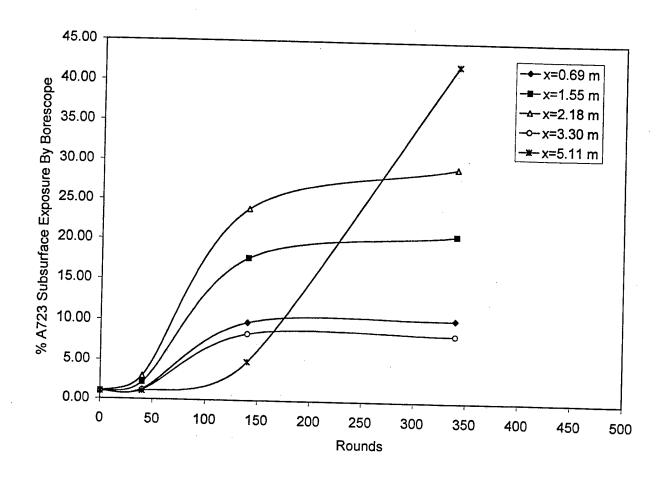
Figure 4 summarizes the M829A2 borescope data analysis of the A723 subsurface exposure through HC chromium plate cracks as a function of rounds fired for selected axial positions. The experimental borescope data was used to calibrate erosion analysis. This data was collected on a cleaned M256 tube that had about half M829A2 and half M829 rounds. These M829A2 and M829 rounds consisted of a nearly equal distribution of hot/ambient/cold temperature conditioning. Data collection involved the use of a magnifying borescope with a calibrated scale to measure the number and average area of each HC chromium platelet within a designated total area as a function of axial position for a given round count.

For the selected axial positions in Figure 4, from 50 to 100 rounds, the A723 subsurface exposure rose rapidly due to HC chromium thermal repacking, nonmetallic out-gassing, and possibly compression resulting in its shrinkage and heat checking. After about 100 rounds, the above mechanism diminished and A723 subsurface exposure rose more slowly because only the HC chromium platelet spalling mechanism remained. At the 5.11 meter from RFT near-muzzle position, the A723 subsurface exposure rose very rapidly from about 100 rounds until its out-of-service round count due to HC chromium platelet spalling by a different purely mechanical mechanism. This tube was taken out-of-service due to dispersion at about seventy percent of its estimated erosion life possibly because of the typical severe muzzle wear.

Figure 4. M829A2 borescope data analysis of the A723 subsurface exposure through HC chromium plate cracks.

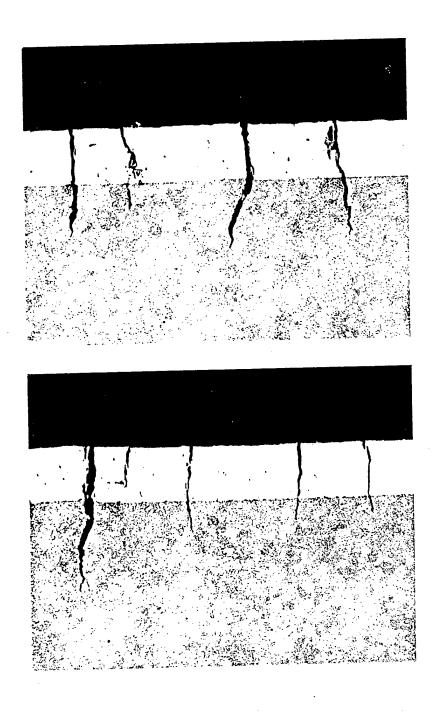
Figure 5 presents two typical 100x metallographs of an M256 tube with about half M829A2 and half M829 rounds at 0.69 meter from RFT. This represents the 0.6 to 1.2 meter region and was used to calibrate the erosion analysis. The 0.6 to 1.2 meter region has the highest gas pressure of any bore region (Figure 1), which explains the deep crack depths due to severe dilation. Although this 0.6 to 1.2 meter region has the highest gas temperature of any bore region (Figure 1), heat transfer to the wall is significantly diminished due to combustion case gas cooling effects (Figure 2). These observations explain the heat checking and crack spacing as well as the near absence of interface degradation and chromium platelet spalling.

Figure 5. Tube #1988 metallographs at 0.69 meter representing 0.6 to 1.2 meters from RFT region (100x).

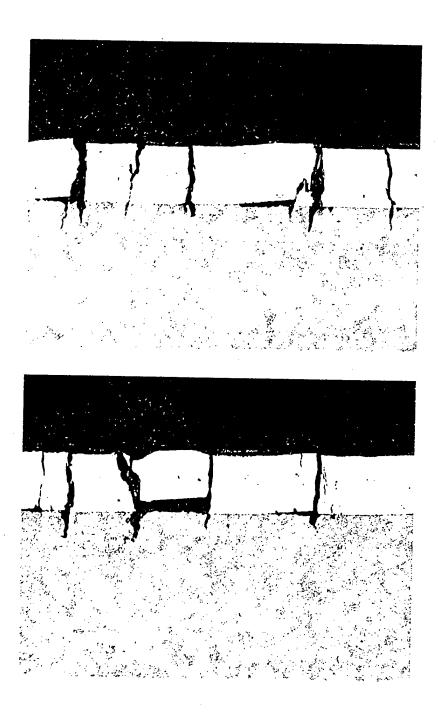
Figure 6 presents two typical 100x metallographs of an M256 tube with about half M829A2 and half M829 rounds at 1.55 meters from RFT. This represents the 1.2 to 2.4 meter region and was also used to calibrate the erosion analysis. The 1.2 to 2.4 meter region has a lower gas pressure than the 0.6 to 1.2 meter region (Figure 1), which explains the moderate crack depths due to moderate dilation. Although this 1.2 to 2.4 meter region has a lower gas temperature than the 0.6 to 1.2 meter bore region (Figure 1), heat transfer to the wall is significantly higher due to turbulent gas mixing (Figure 2). These observations explain the heat checking and crack spacing as well as the prevalent interface degradation and chromium platelet spalling. We theorize that the main gun erosion mechanism consists of inert chromium plate cracking, shrinkage, and heat checking, followed by subsequent interfacial degradation of the subsurface gun steel substrate at the chromium crack bases, subsequent chromium platelet spalling, and subsequent bare gun steel gas wash. The gun steel at the chromium/gun steel interface is more susceptible to interface degradation than either of its components separately due to its higher energy state and reactivity. In addition, interface degradation is enhanced by expansive flaking of iron oxide.

As chromium platelets detach from the substrate and rise above attached chromium platelets, they are more susceptible to mechanical removal by the projectile. In addition, the 1.2 to 2.4 meter region has a wavy chromium surface appearance in cross-section due to partially detached chromium platelets. Rarely do radial heat-checking cracks link-up to spall a chromium platelet with attached gun steel. Although there appears to be evidence of heat-checking cracks extending into the wall well beyond the heat-affected zone due to environmental-assisted cracking, great scrutiny has produced no measurable evidence of chromium platelet spalling due to cracking in the plane of the chromium plate/gun steel interface.

Figure 6. Tube #1988 metallographs at 1.55 meters representing 1.2 to 2.4 meter region (100x).

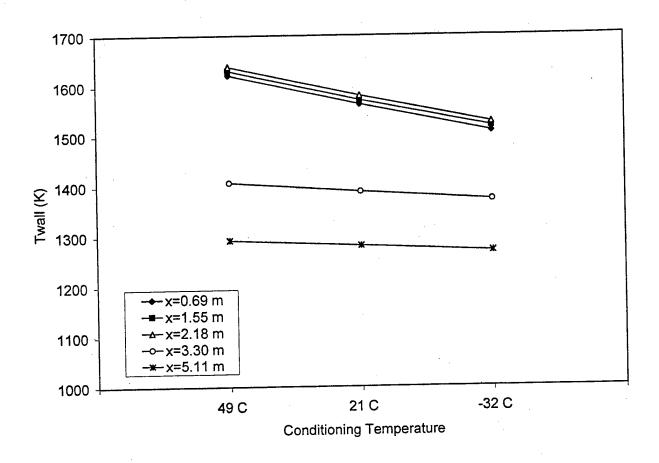
Figure 7 shows the M256/M829A2 MACE wall temperature profile analysis for HC chromium maximum surface temperature (T_{wall}) as a function of round-conditioning temperatures for selected axial positions. The HC chromium maximum T_{wall} is about 1650°K, which is below its passivating oxidation temperature at about 2000°K, and well below its melting point at about 2130°K, thus explaining its inertness.

Figure 7. M256/M829A2 calibrated MACE wall temperature profile analysis for HC chromium maximum surface temperature.

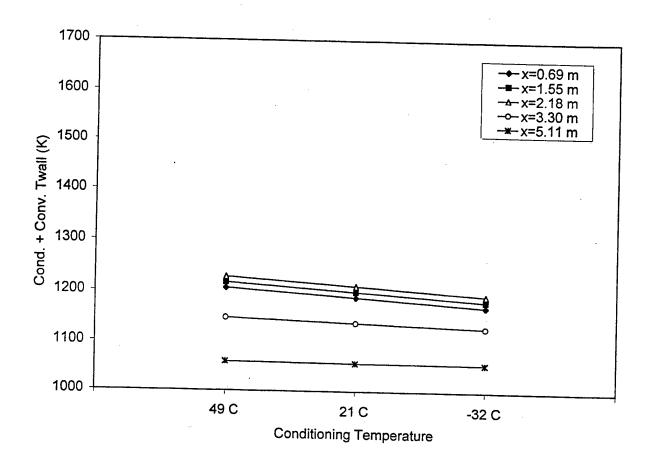
Figure 8 shows the M256/M829A2 MACE wall temperature profile analysis for A723 maximum interface wall temperature (T_{wall}) as a function of round-conditioning temperatures for selected axial positions. The T_{wall} values are a combination of convection and conduction at the crack walls. The A723/iron maximum interface T_{wall} is about 1250°K, which is above its rapid expansive flaking oxidation temperature at about 1055°K, explaining its reactivity. In addition, it is below its iron oxide melting point at about 1640°K and well below its A723/iron melting point at about 1810°K. Diffusion, reactions, transformations, and gas wash thermochemically degrade interfacial A723 at HC chromium plate heat-checked crack bases.

Figure 8. M256/M829A2 calibrated MACE wall temperature profile analysis for A723 maximum interface wall temperature.

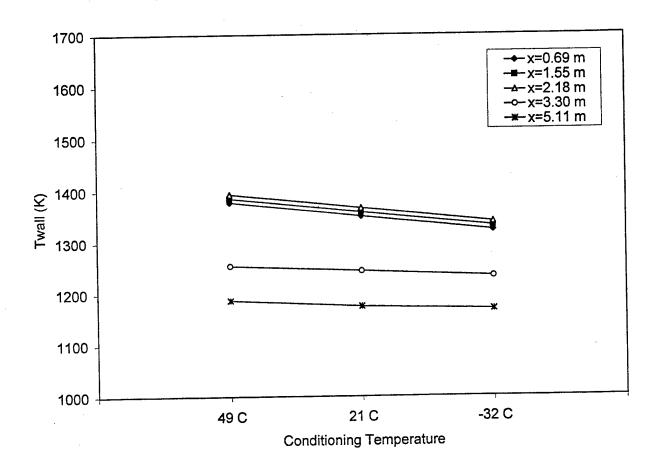
Figure 9 shows the M256/M829A2 MACE wall temperature profile analysis for A723 maximum surface wall temperature (T_{wall}) as a function of round-conditioning temperatures for selected axial positions. The A723/iron maximum surface T_{wall} is about 1400°K, which is well above its rapid expansive flaking oxidation temperature at about 1055°K, explaining its reactivity. In addition, it is below its iron oxide melting point at about 1640°K and well below its A723/iron melting point at about 1810°K. Diffusion, reactions, transformations, and gas wash thermochemically degrade fully exposed surface A723 after HC chromium plate spalling.

Figure 9. M256/M829A2 calibrated MACE wall temperature profile analysis for A723 maximum surface wall temperature.

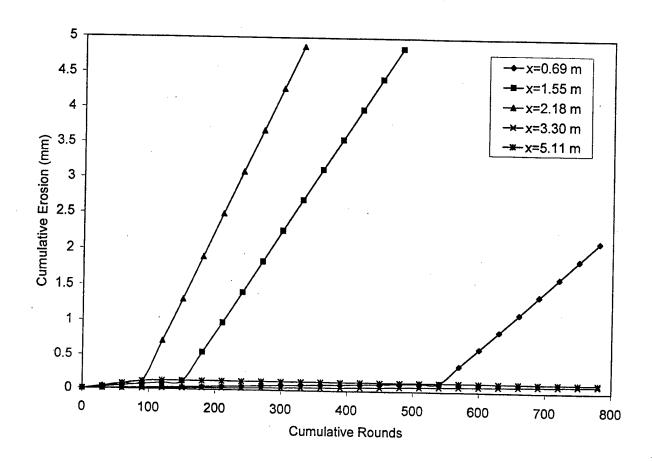
Figure 10 summarizes the M256/M829A2 MACE cumulative erosion analysis for the unrealistic, but informative case of only 49°C conditioned rounds as a function of cumulative rounds for selected axial positions. The figure shows the 2.18 meter axial position to be the most eroded position. It takes about 100 rounds for chromium platelet spalling onset/gun steel gas wash onset to occur. It takes about 340 rounds to achieve the 5 mm of cumulative erosion required to condemn this gun on erosion, and it takes about 250 rounds to achieve about 3 mm of cumulative erosion typical of the erosion damage when this gun is taken out-of-service for excessive dispersion at about seventy percent of its erosion life.

Figure 10. M256/M829A2 MACE cumulative erosion analysis for the unrealistic, but informative case of only 49°C conditioned rounds.

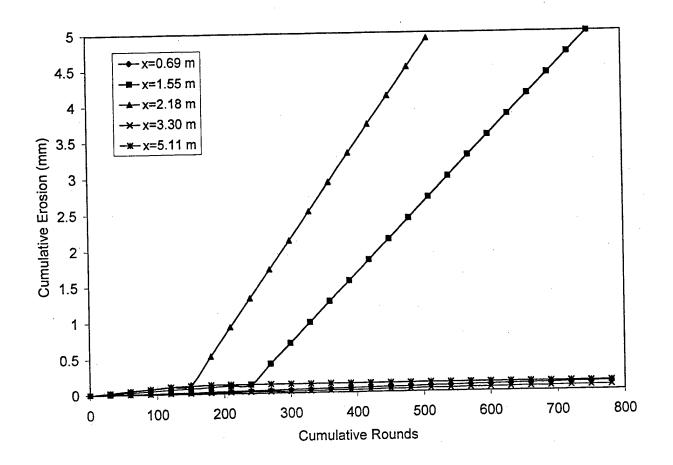
Figure 11 summarizes the M256/M829A2 MACE cumulative erosion analysis for the unrealistic, but informative case of only 21°C conditioned rounds as a function of cumulative rounds for selected axial positions. The figure shows the 2.18 meter axial position to be the most eroded position. It takes about 150 rounds for chromium platelet spalling onset/gun steel gas wash onset to occur. It takes about 510 rounds to achieve the 5 mm of cumulative erosion required to condemn this gun on erosion, and it takes about 380 rounds to achieve about 3 mm of cumulative erosion typical of the erosion damage when this gun is taken out-of-service for excessive dispersion at about seventy percent of its erosion life.

Figure 11. M256/M829A2 MACE cumulative erosion analysis for the unrealistic, but informative case of only 21°C conditioned rounds.

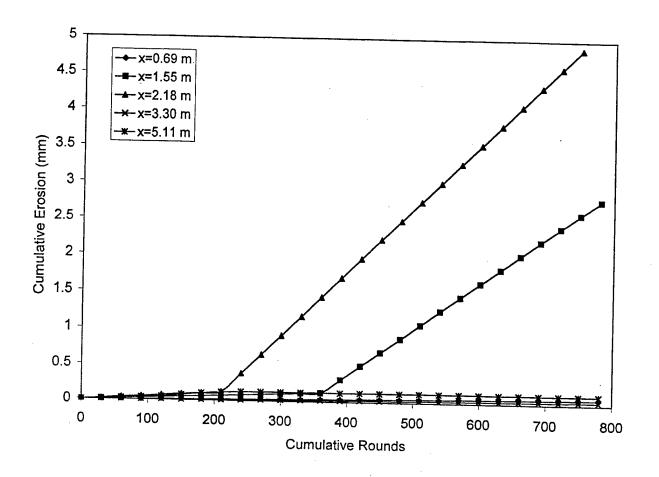
Figure 12 summarizes the M256/M829A2 MACE cumulative erosion analysis for the unrealistic, but informative case of only -32°C conditioned rounds as a function of cumulative rounds for selected axial positions. The figure shows the 2.18 meter axial position to be the most eroded position. It takes about 210 rounds for chromium platelet spalling onset/gun steel gas wash onset to occur. It takes about 770 rounds to achieve the 5 mm of cumulative erosion required to condemn this gun on erosion, and it takes about 560 rounds to achieve about 3 mm of cumulative erosion typical of the erosion damage when this gun is taken out-of-service for excessive dispersion at about seventy percent of its erosion life.

Figure 12. M256/M829A2 MACE cumulative erosion analysis for the unrealistic, but informative case of only -32°C conditioned rounds.

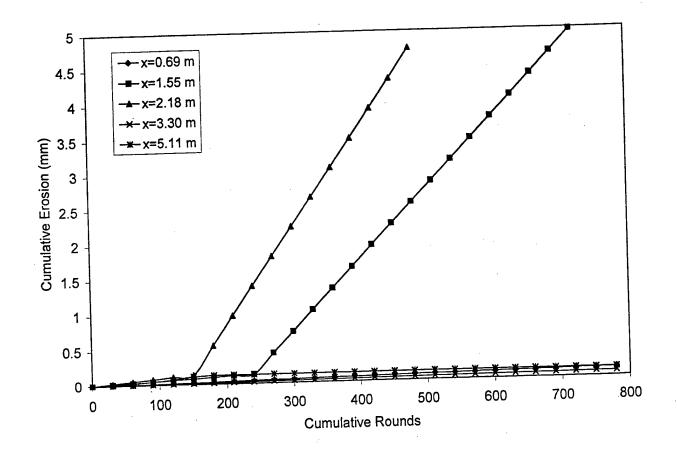
Figure 13 summarizes the M256/M829A2 MACE cumulative erosion analysis for the semi-realistic and informative case of an equal distribution of hot/ambient/cold-conditioned rounds as a function of cumulative rounds for selected axial positions. This figure also shows the 2.18 meter axial position to be the most eroded position. It takes about 150 rounds for chromium platelet spalling onset/gun steel gas wash onset to occur. It takes about 480 rounds to achieve the 5 mm of cumulative erosion required to condemn this gun on erosion, and it takes about 350 rounds to achieve about 3 mm of cumulative erosion typical of the erosion damage when this gun is taken out-of-service for excessive dispersion at about seventy percent of its erosion life.

Figure 13. M256/M829A2 MACE cumulative erosion analysis for the semi-realistic and informative case of an equal distribution of hot/ambient/cold-conditioned rounds.
